FRC ON-SITE AIR BAG DEPLOYMENT INVESTIGATION

CASE NO. 90-13

FLEET - 1988 ACURA LEGEND

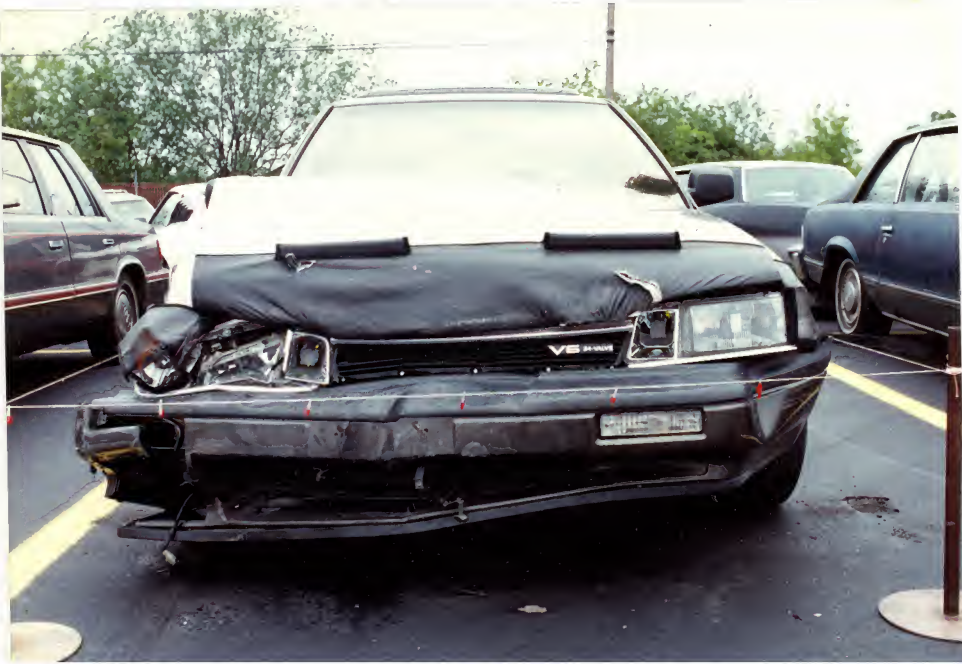
Frontal View Of The Acura Legend.

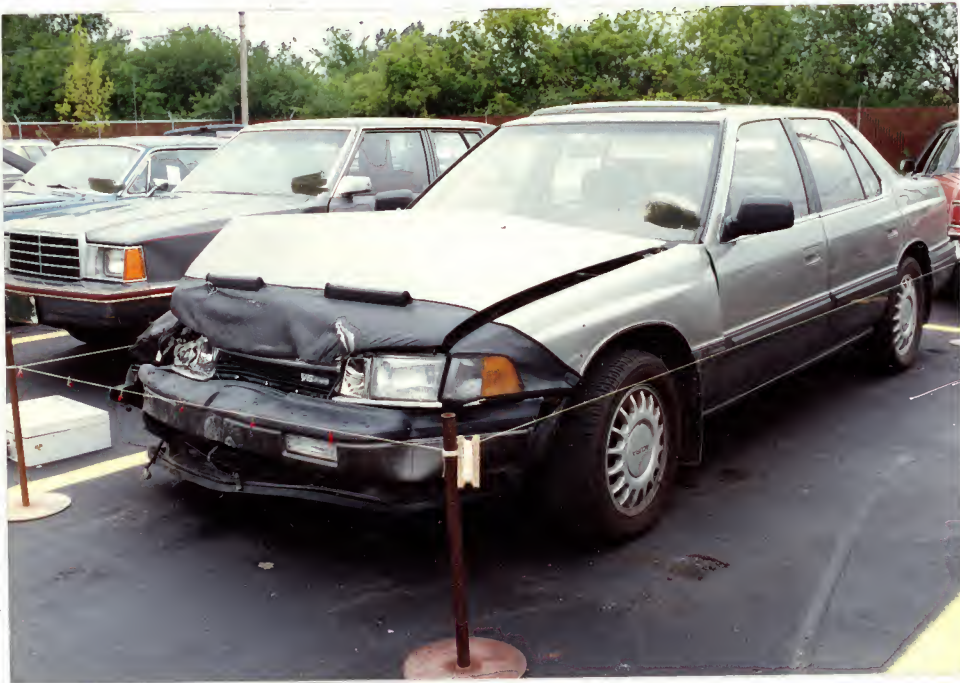
3.

Left Front Three-Quarter View.

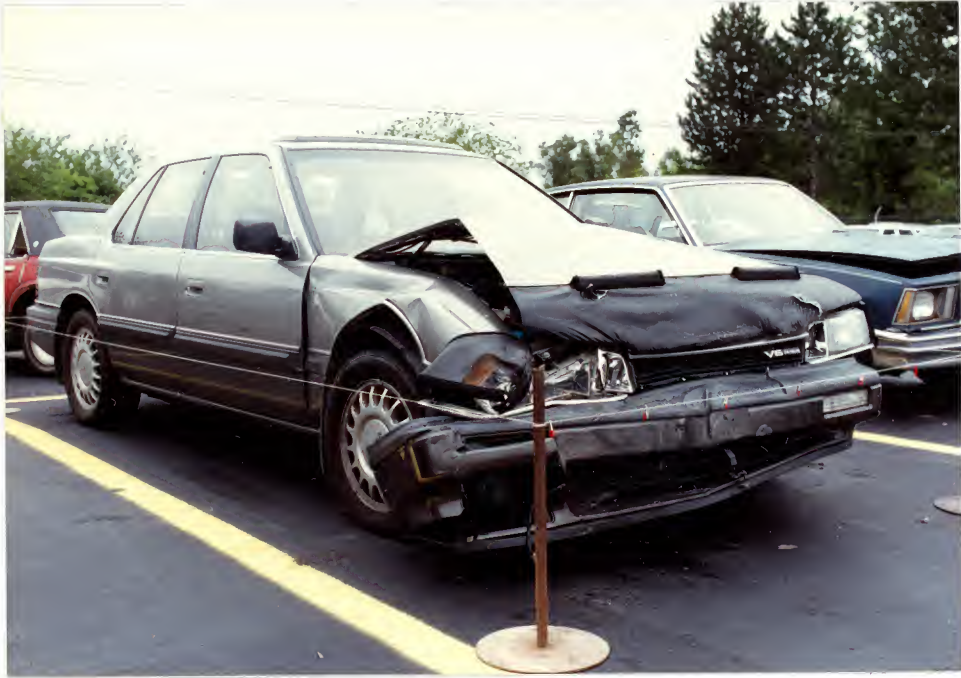
4.

The frontal area of the Acura Legend impacted the right side of vehicle #2. Maximum crush was 15.5" located on the front bumper at the right corner. Direct contact damage was 62.5" in length and extended across the entire frontal plane. Crush values at bumper level were as follows: C₁=1.5", C₂=2.5", C₃=5.5", C₄=7.625", C₅=9.5", C₆=15.5".

Components damaged by the impact included the front bumper, grille, hood, radiator support panel, both front fenders, and the front unibody chassis.

Right Frontal Three-Quarter View.

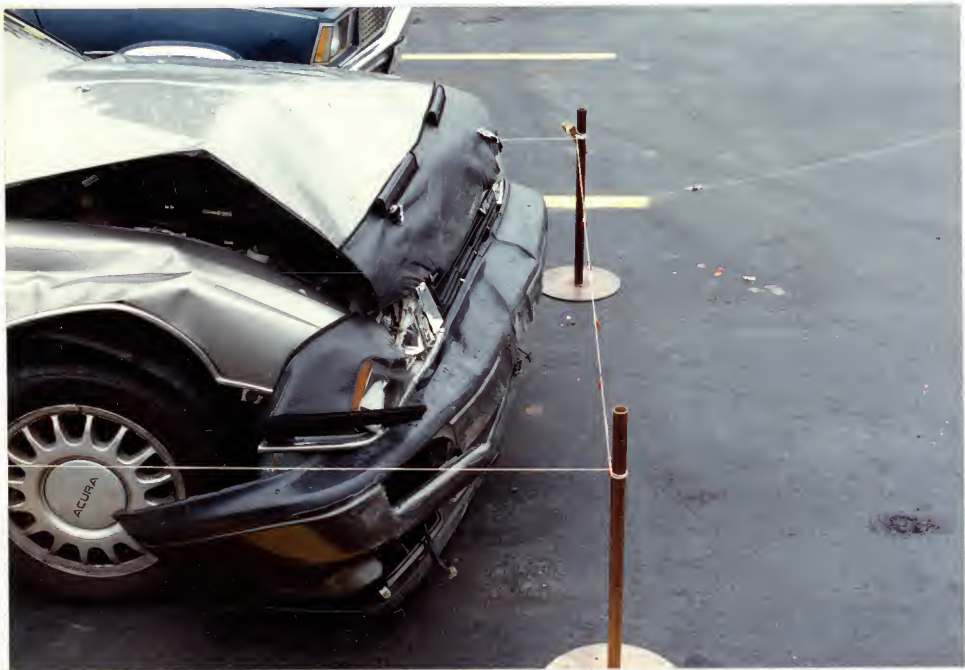
5.

Perpendicular View Of The Frontal Plane Showing The Extent Of Crush.

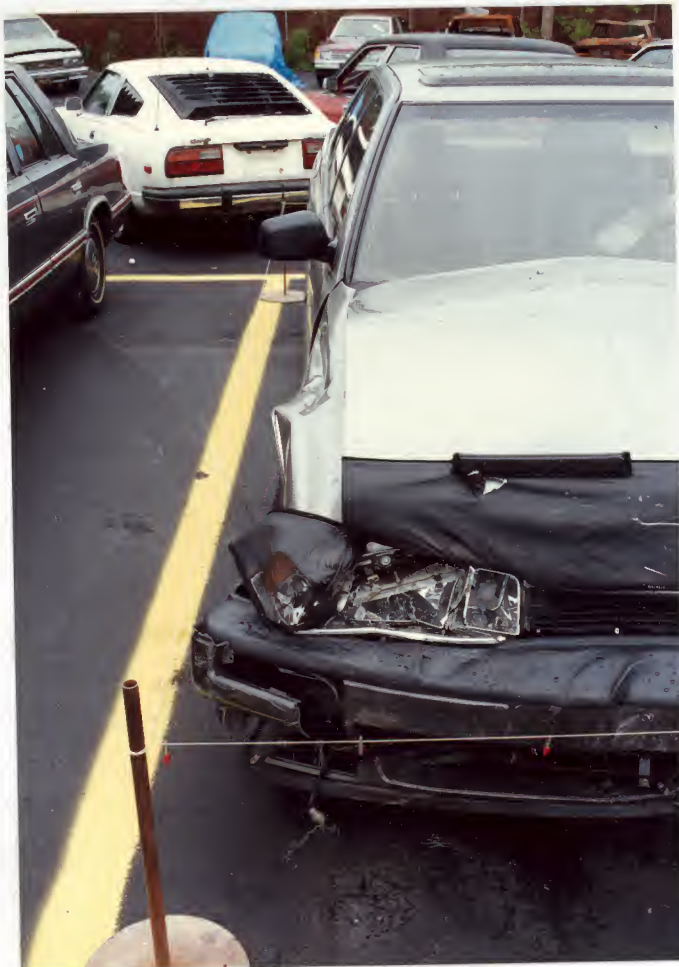
6.

Longitudinal View Showing The Lateral Displacement Of The Frontal Plane.

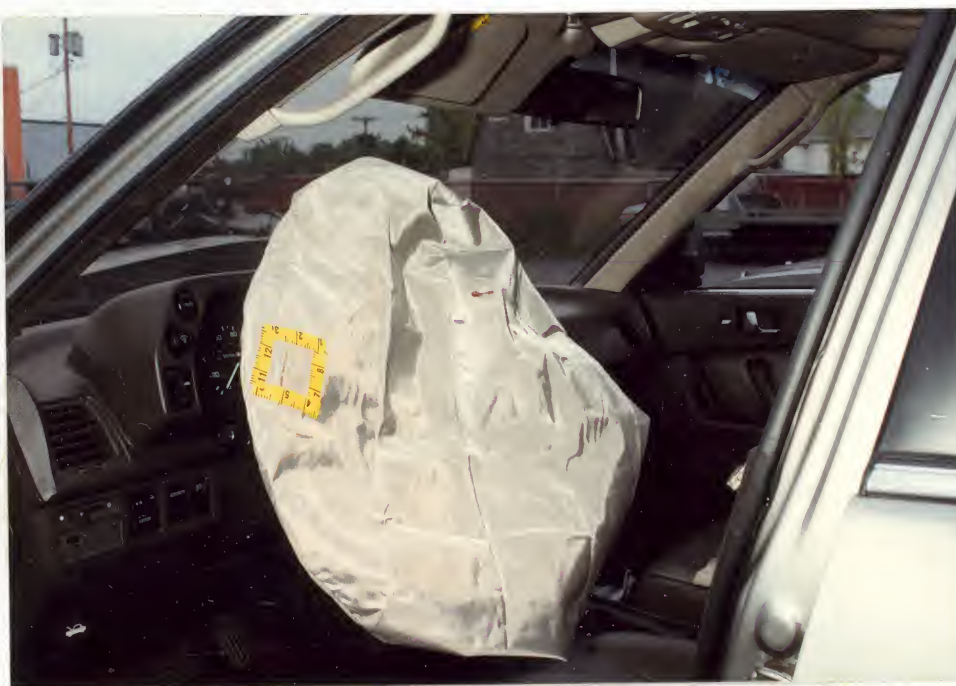
The Acura Legend was equipped with a driver air bag system that deployed as a result of the frontal impact sequence. The deployed air bag measured approximately 24" in diameter and was vented through two ports that were 1.25" in diameter located on the back (module) side of the air bag. The bag did not have an internal tether strap and was stitched together with an internal seam. There were no tears or apparent flaws in the bag material.

Overall Interior View And The Deployed Air Bag.

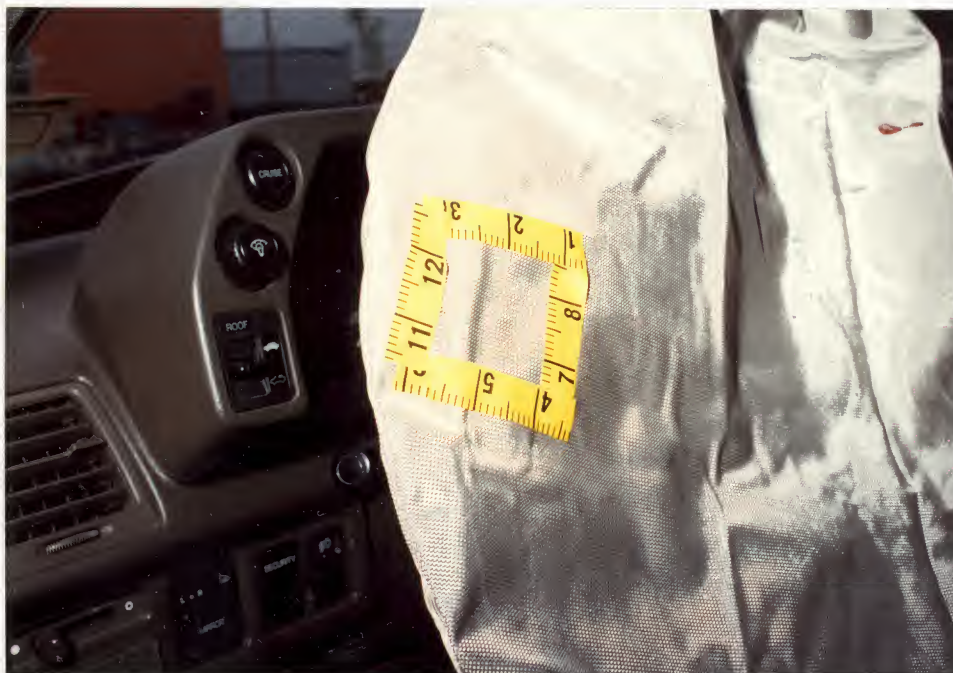
The interior of the Acura Legend was not damaged or reduced in size by component intrusion. The driver loaded the deployed air bag and deposited a make-up transfer (1" in diameter) 9" above the horizontal centerline of the bag and 1.5" left of the vertical centerline. Blood stains were also noted to the right lower quadrant of the bag.

Driver Facial Contact (Makeup Transfer) To The Left Upper Quadrant
The Air Bag.
